USAARL REPORT NO. 72-07

DYNAMIC AND CRASHWORTHY EVALUATION
OF THE UH-1B, C, D, H, MEDICAL ATTENDANT'S SEAT

January 1972

U. S. ARMY AEROMEDICAL RESEARCH LABORATORY

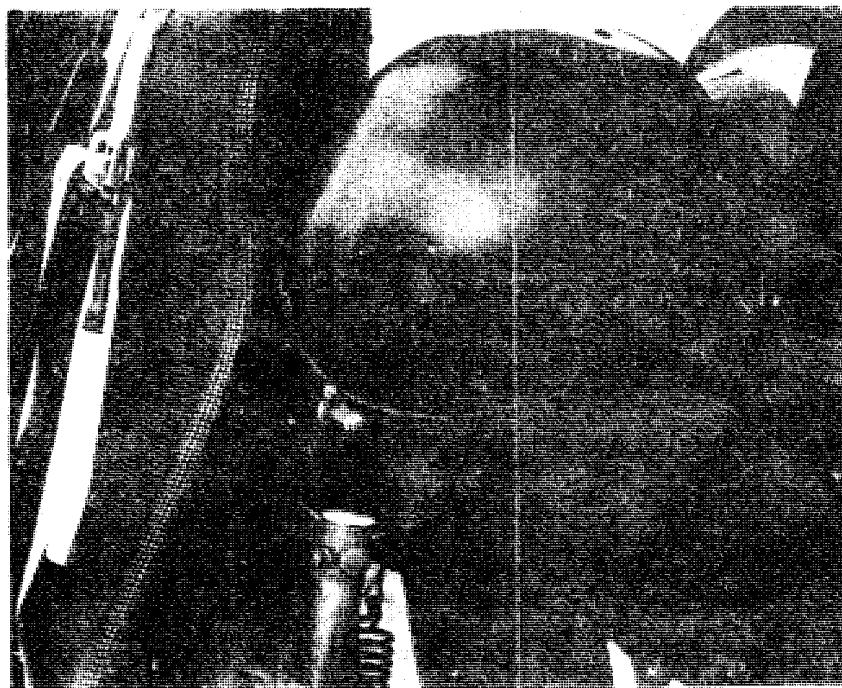
Figure 1. Possible Fatal or Morbid Injuries When Seat is Installed Behind Pilot - Copilot Seats with Maximum Rearward Adjustment.

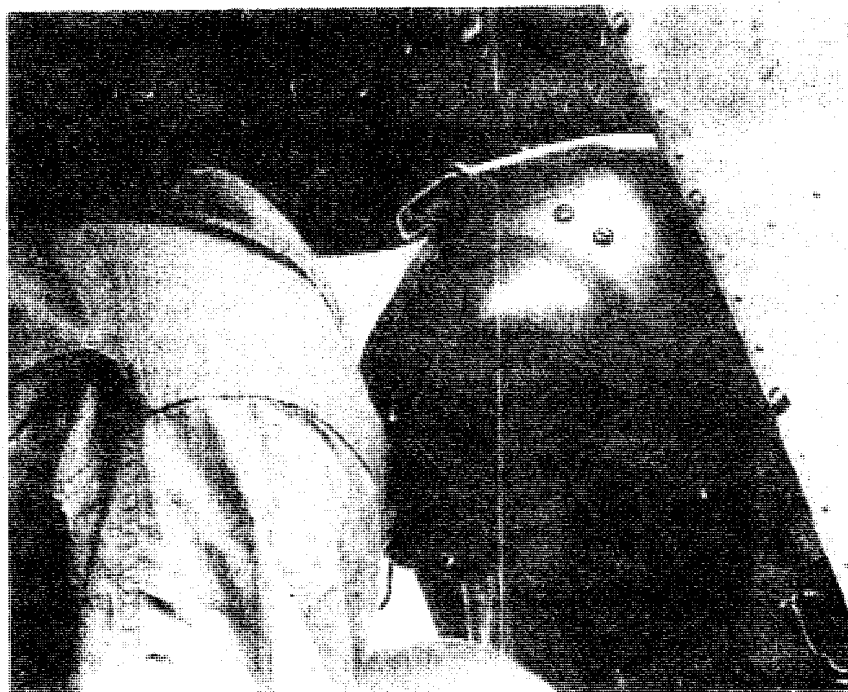
Figure 2. Demonstration of Head - Seat Contact is Allowed by Basic Seat When Used Behind Crew Seat and Without Shoulder Harness.

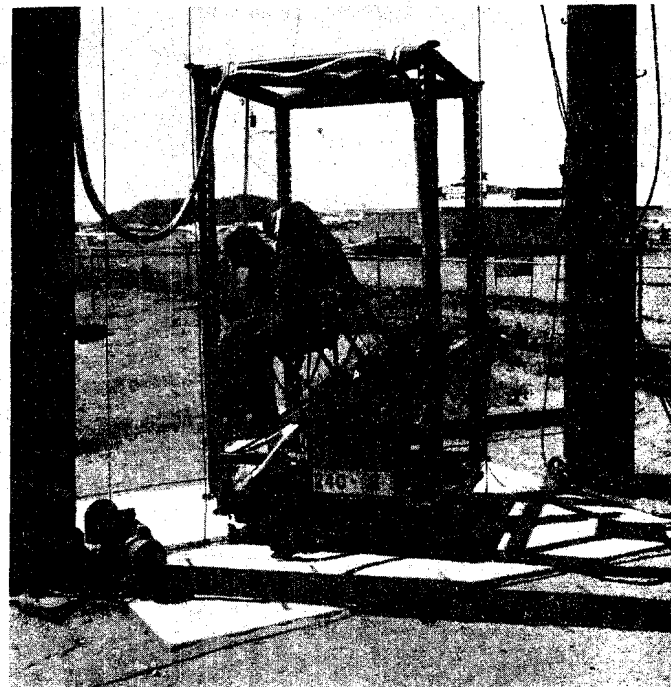
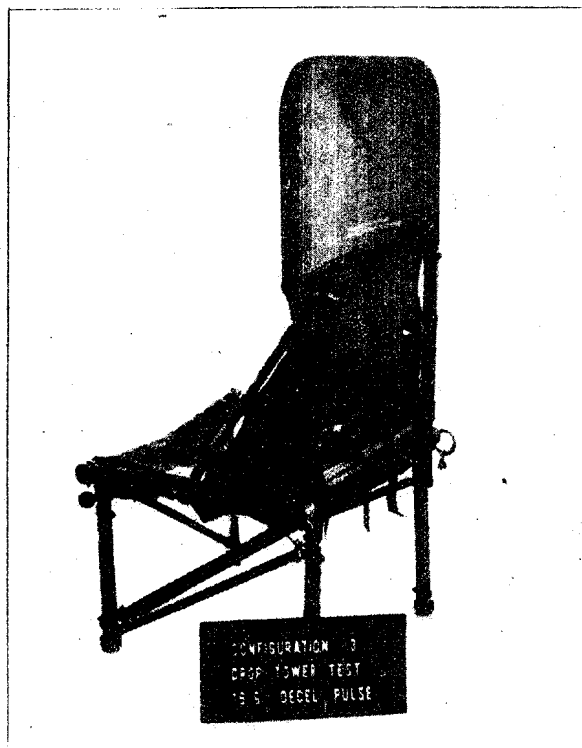
Post-test inspection revealed seat failure in four places. The seat front lateral cross tube failed in the center at a 1/8-inch diameter hole where a screw fastens the seat canvas to the structure, the seat right front corner joint pulled out, the seat back tube failed on the left side at the back brace tube, and the canvas seat also failed. Figure 26 shows a post-test seat side view. Peak dummy chest vertical deceleration was 23.8G. The pelvis experienced a very high vertical deceleration of 40G. (See Figures 24 thru 31.)

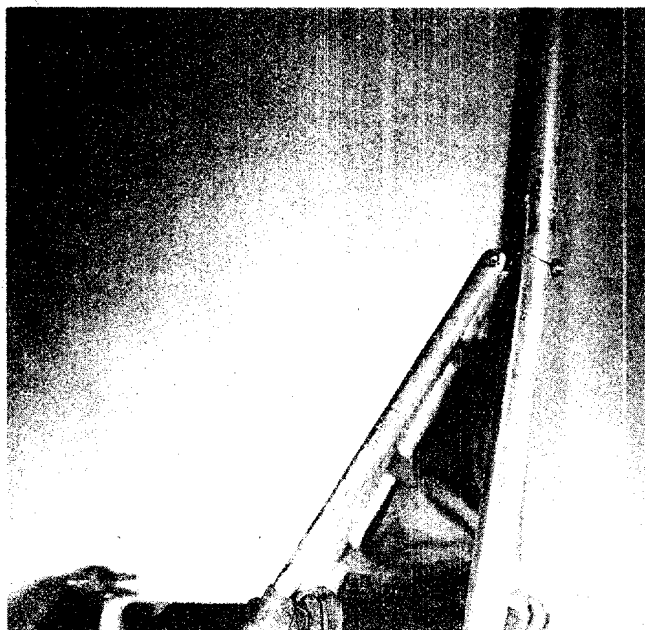
Figure 27. Closeup of Seat Back Failure
Slip-out of Joint in Background.

From the nature of the failure it is obvious that the aluminum seat back is very brittle in nature. The support tube pin served as a pivot about which only 150 + ft-lbs were necessary to fail the notch-sensitive tube.

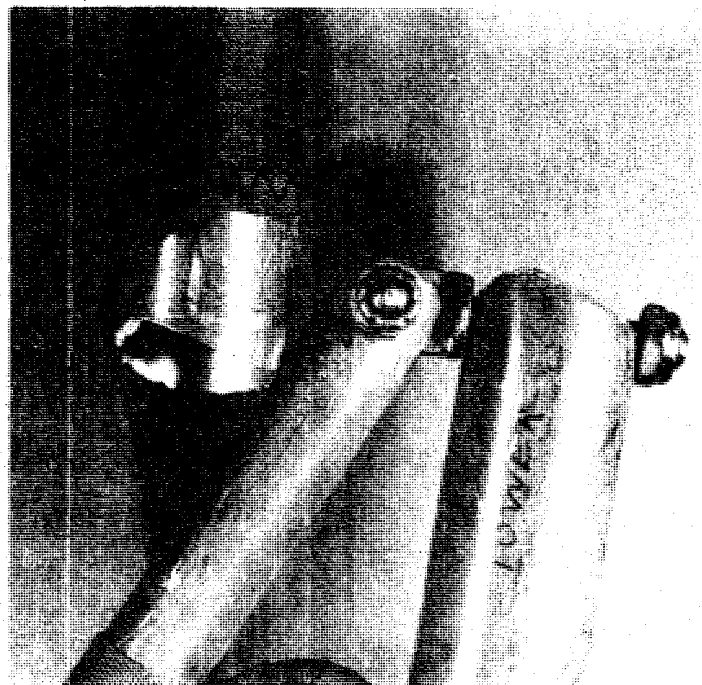
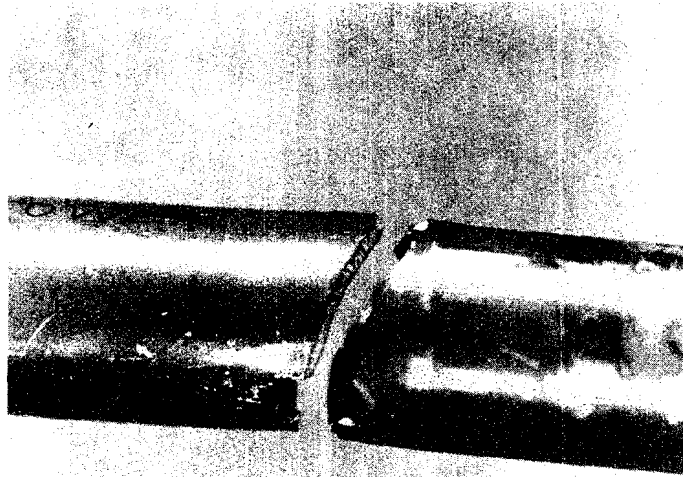
Figure 29. Closeup of Failed Seat Back

Figure 30. Closeup, Seat Back Failure

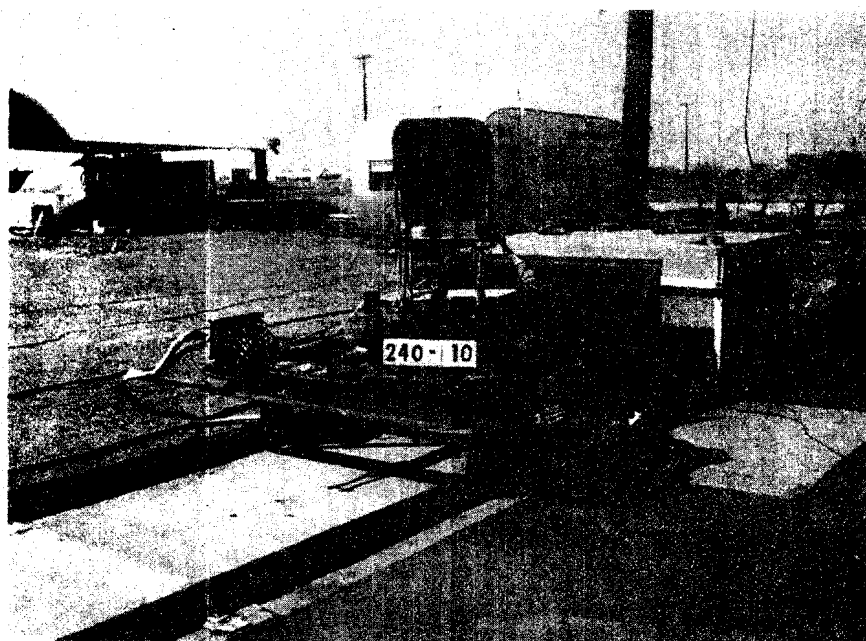
Post-test inspection revealed a broken left side lap belt anchor ring (See Figures 35 and 37). This allowed the dummy to move out of the seat onto the right side of the sled during impact. The dummy and instrumentation were not damaged, however, high decelerations resulted. The highest deceleration measured was a 24.2G lateral chest deceleration.

Figure 36. Post-test Position of Dummy in Test 10.

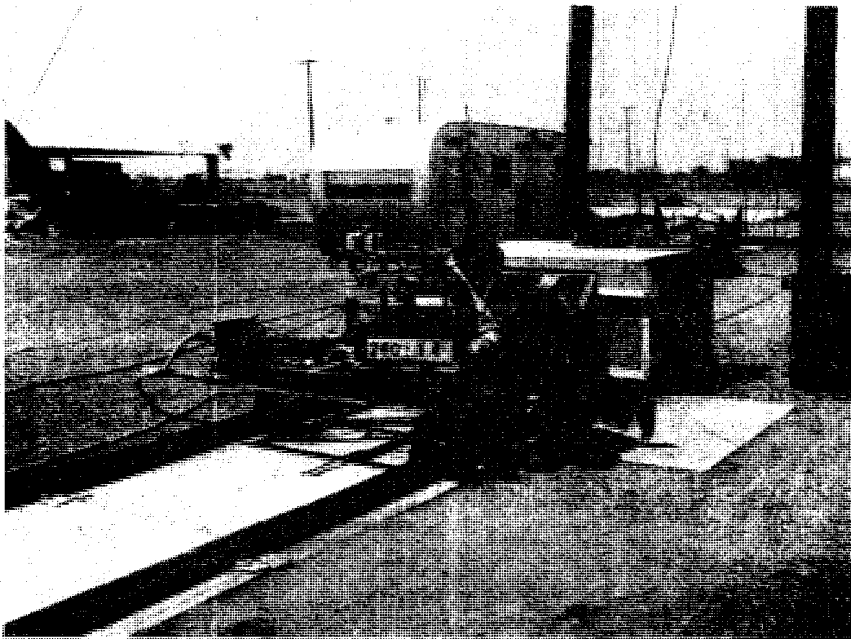
Figure 42. Post-test Position of Dummy After Test 14.

Post-test inspection revealed four failures as shown in Figures 42 thru 44. The seat back tube failed at the back brace tube bolt holes, the left lap belt ring weld failed, the right front seat joint started to pull loose, and the seat canvas failed. The dummy moved out of the seat and onto the left side of the sled; however, the dummy and instrumentation were not damaged. (See Figures 41 thru 44.) The maximum dummy deceleration was measured in the chest and was 13.9G in the vertical direction.

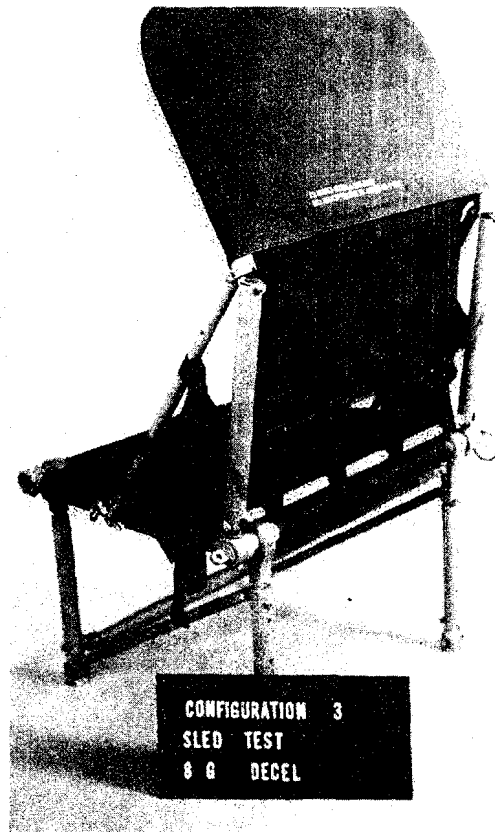
Figure 43. 8G Input, Configuration 3.

Note the absence of the left lap belt attachment ring which broke at 1,340 lbs. Refer to Figure 55 on page 63 for a picture and discussion of this type failure. Note also that the failure of the seat back on both sides occurred at the support tube pin. The torque causing these failures was 530 + lbs-ft total, applied near the center of the two failures.

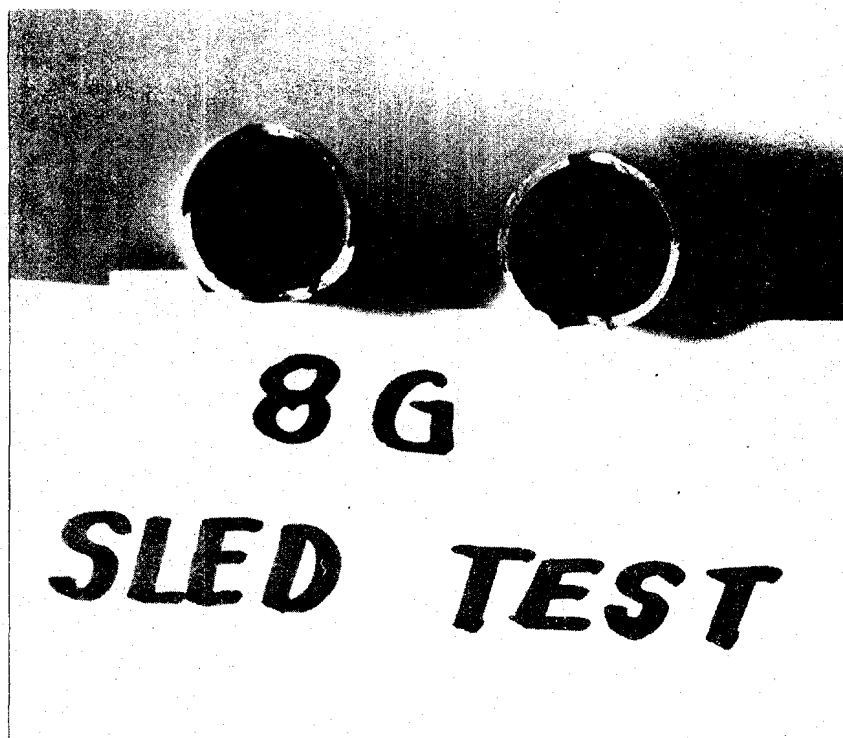
Figure 44. End View of Failed Seat Back Tubes.

The picture in Figure 44 shows an end-to-end view of one of the failures of the seat back tube.

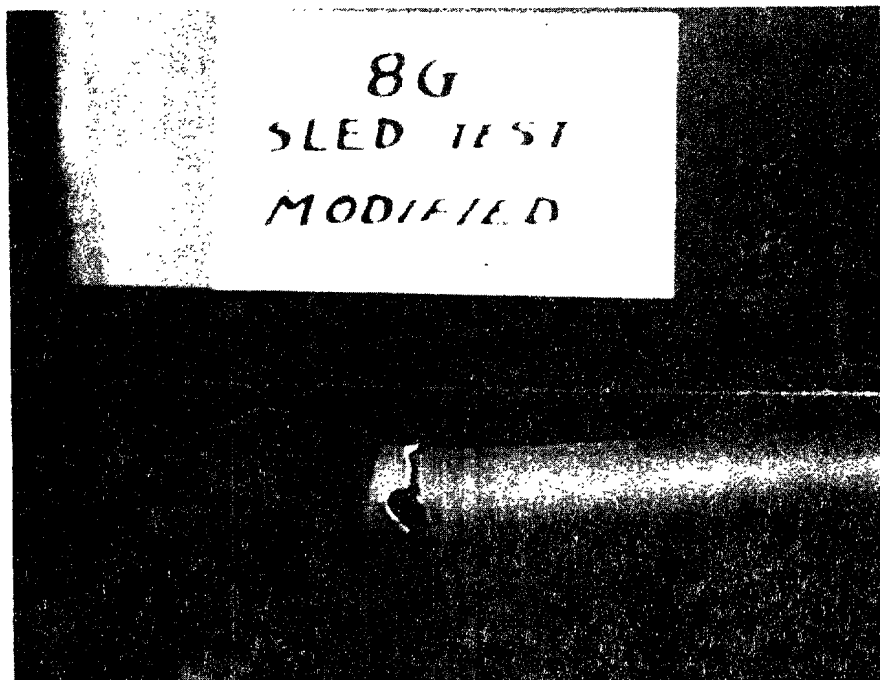
Figure 50. Closeup Longitudinal Frame Failure

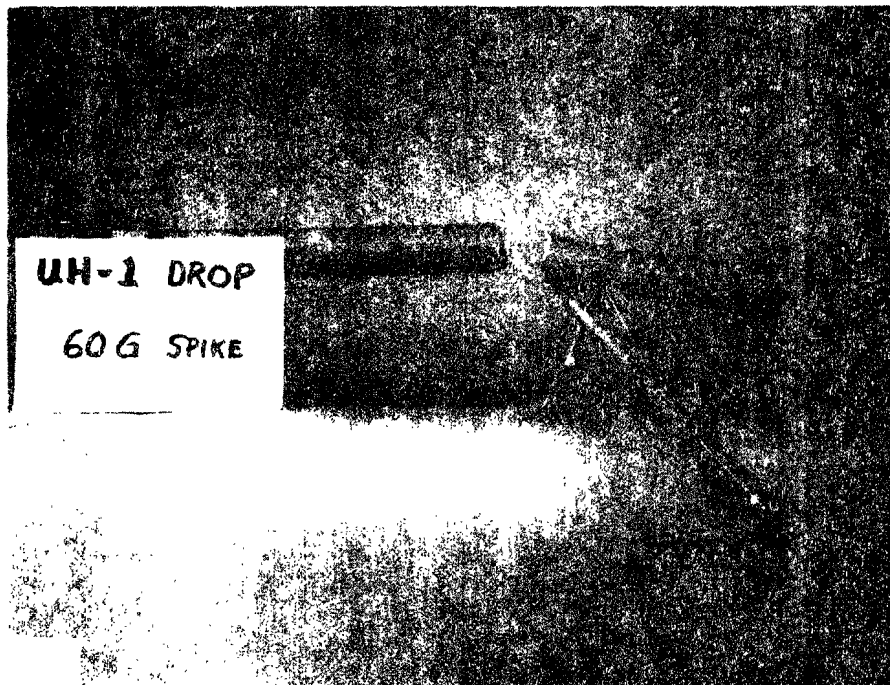
Figure 53. Closeup of Front Cross Tube.
Note Break Through Screw Hole.

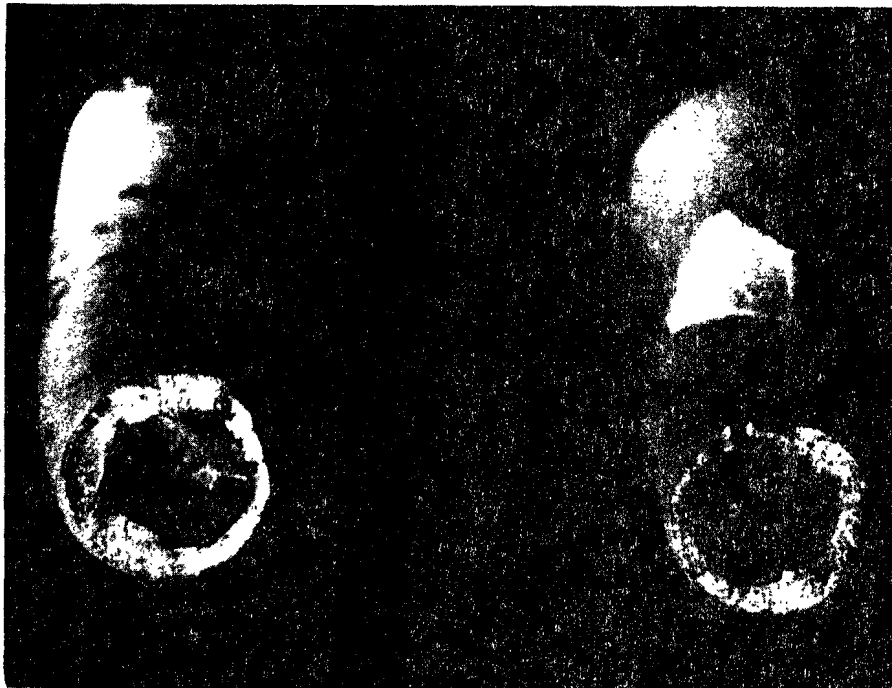
An X-ray, metalurgical, and tensile evaluation was performed on two unfailed and one failed ring. X-ray and visual examination demonstrated voids, gas holes, and incomplete welds. The weld failures during the dynamic tests and static tensile tests appear brittle (ductility is desired). Weld hardness on specimens examined ranged from 20 Rockwell C to 44 Rockwell C (equivalent to hardened steel). There is no evidence of weld annealing. Ultimate tensile strength ranged from 2,000 pounds to 6,600 pounds. This compares with the expected values from the hardness values. In general, the welds are of unacceptable quality and must be considered unsafe for the lap belt attachment point.

Figure 55. 4x Magnification of the Failed Weld Portion of a Lap Belt Attachment Ring. The Lighter Colored Area Around the Circumference of the Ring is Brittle Weld Material. The Arrow Points to a Blow (Gas) Hole.
